# ECHOMASTER

## Technical Bulletin

**Models Affected:** EM-BUC-KIT-JW, EM-JP-CAM, FC-WRANGLER, FC-WRANGLERPRO, FC-WRANGLERPRO-RSC, PCAM-JP2

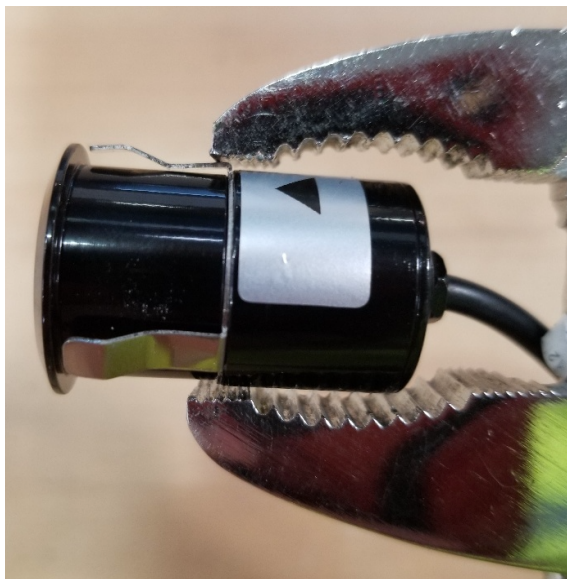
**Cause:** It has been found that the spring clips located on the PCAM-220 camera housing may have incorrect bends. These bends cause the diameter of the PCAM-220 camera to exceed diameter of the mounting hole of the JP-MOUNT, resulting in difficulty inserting the PCAM-220 into the JP-MOUNT.

Using a set of Channel Locks or Pliers, position the tool on the clip as shown above and squeeze to compress the clip. Repeat this for all three clips located on the PCAM-220 camera.
